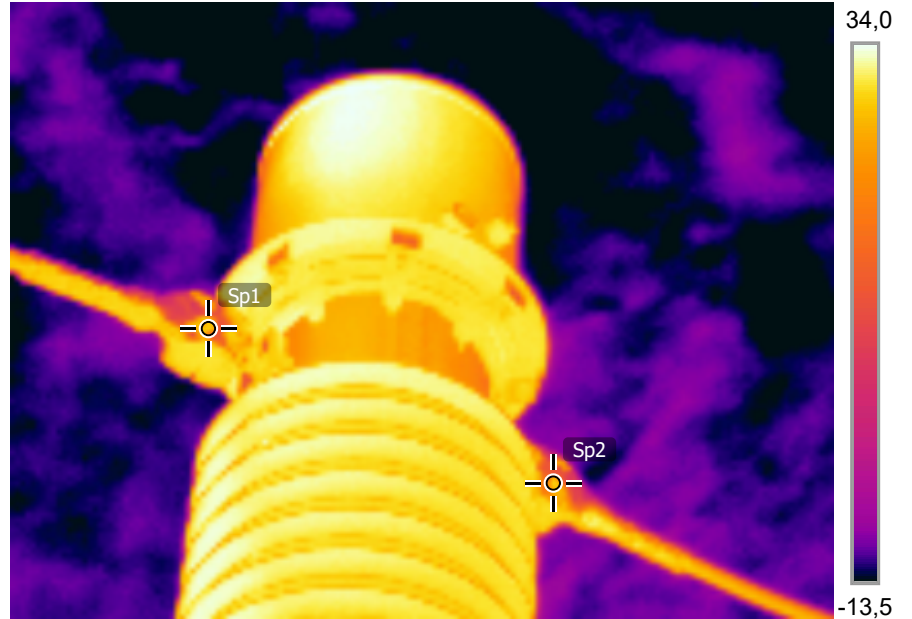
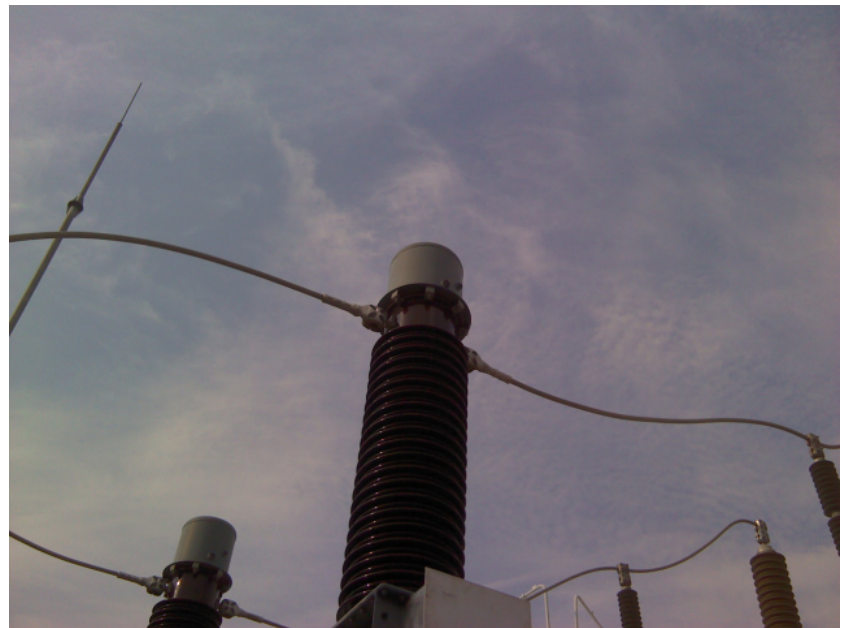
IR_0655.jpg

| Sp1 | 29,8 °C |
| Sp2 | 30,2 °C |

- All 132KV CT, VT and CB connections look good with no hot connections.

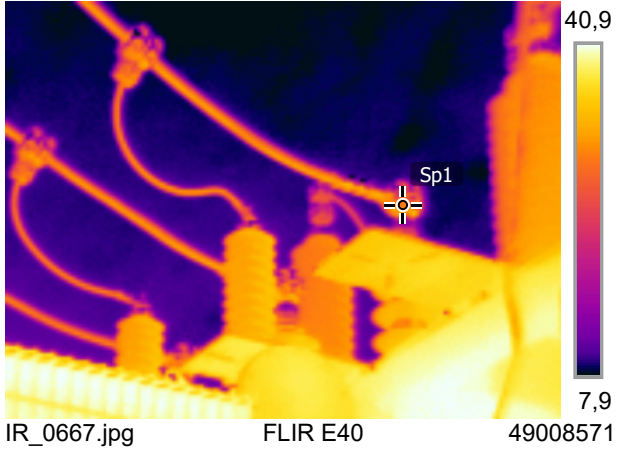
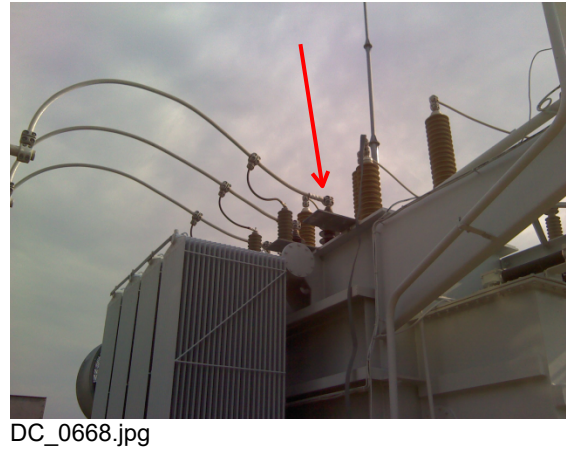
| Sp1 | 30,4 °C |

- All 22KV connections on TRFR 1 and 2 look good with no hot connections.

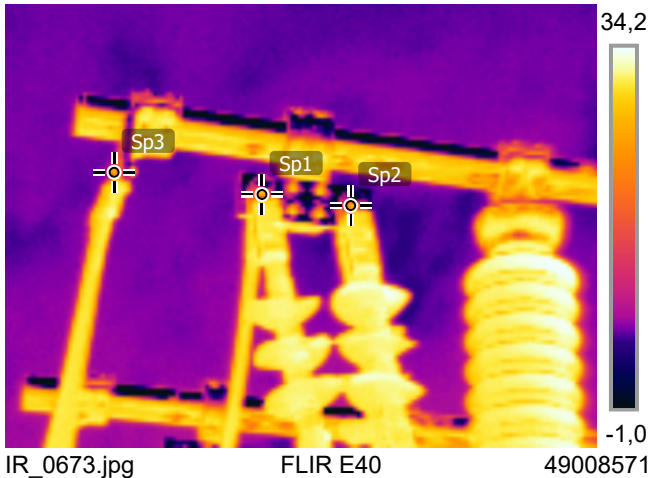
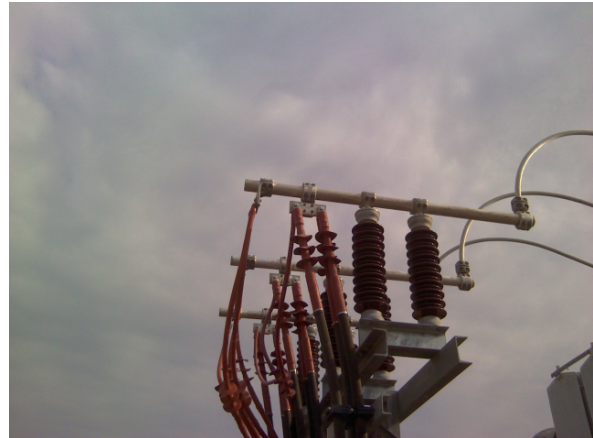
| Sp1 | 28,6 °C |
| Sp2 | 28,4 °C |
| Sp3 | 28,0 °C |

- All 22KV cable connections on TRFR 1 and 2 are in good order with no hot connections.

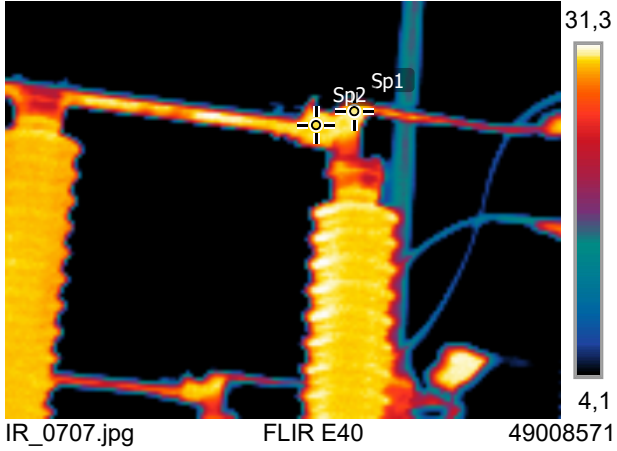
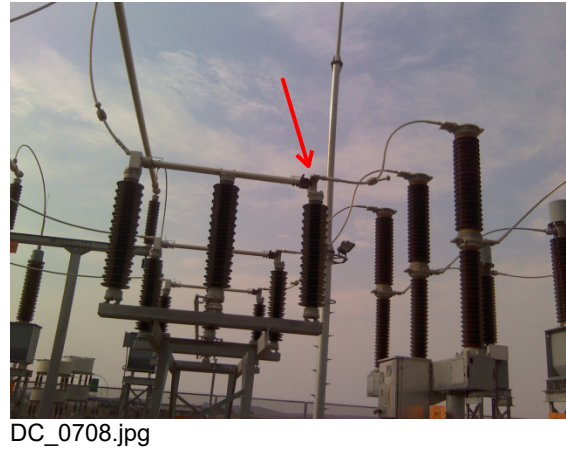
| Sp1 | 30,5 °C |
| Sp2 | 30,3 °C |

- All 132KV link connections look good with no hot connections.

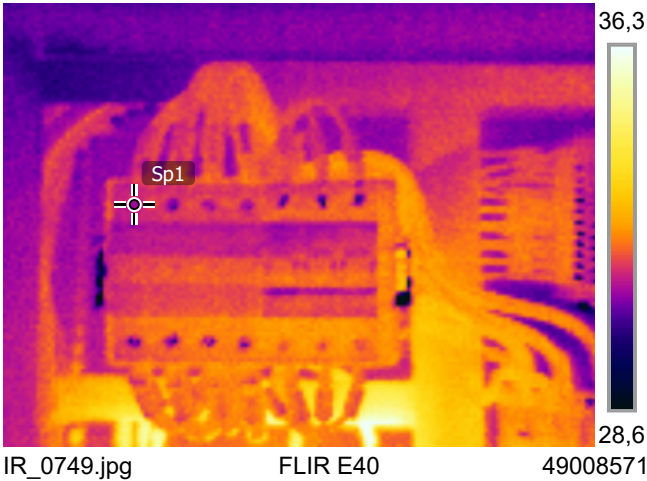
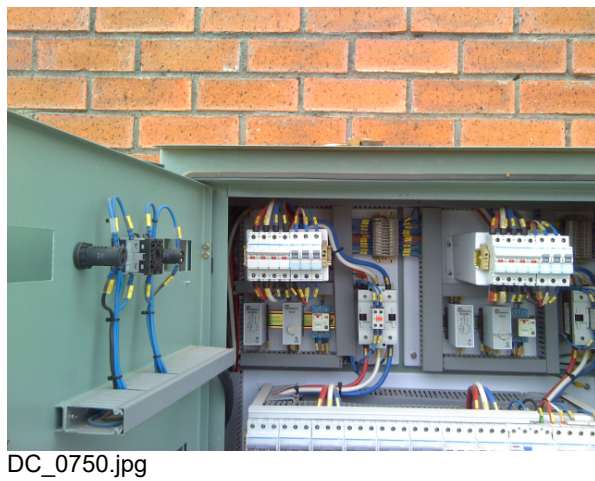
| Sp1 | 31,1 °C |

- All connections in LV Yard box are in good order with no hot connections.
- No further actions are required.
